## VERTICAL HOME INSPECTIONS RESIDENTIAL REPORT

1234 Main St  
85390

Sample Client  
JANUARY 15, 2023

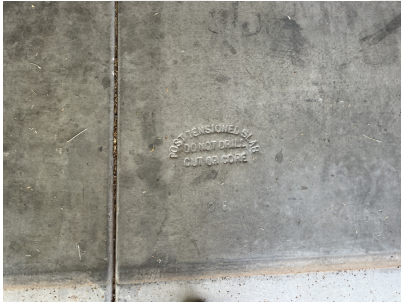
#### 6) Foundation: Post Tension Identification

Garage

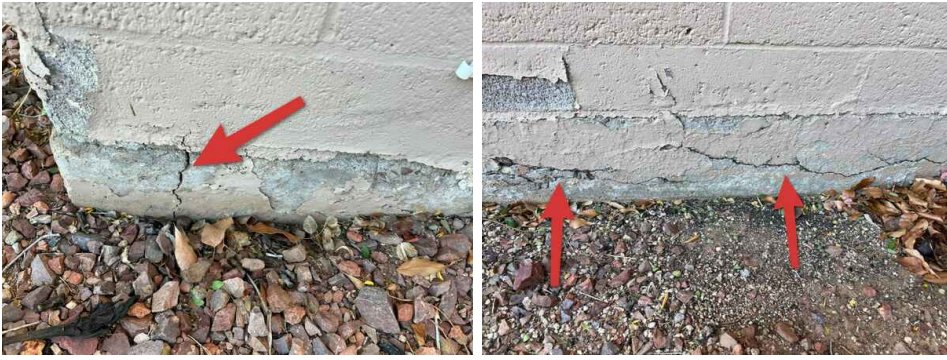
#### FOUNDATION CRACKS - MAJOR

EAST

Severe cracking noted at the foundation. This is typically consistent with soil movement and could lead to serious damage to structural components, foundation and/or slabs. Recommend a structural engineer evaluate and provide a report on course of action and remedy.

Contact a foundation contractor.

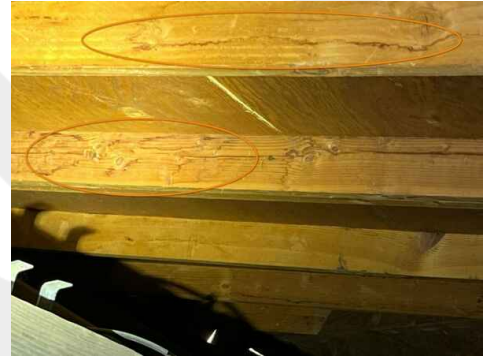
**MOISTURE STAINING**

ATTIC

Moisture stains were noted in various areas of the attic including around roof penetrations, rafters/trusses and decking. Although unconfirmed, a majority of the staining is most likely the result of a leaking, recommend monitoring and repairs as needed.

Contact a qualified professional.

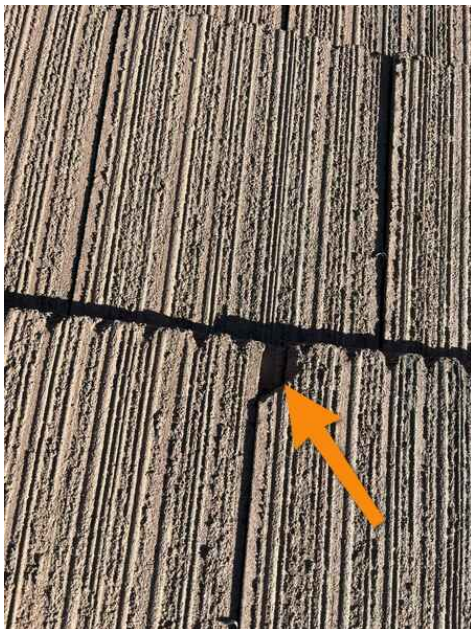
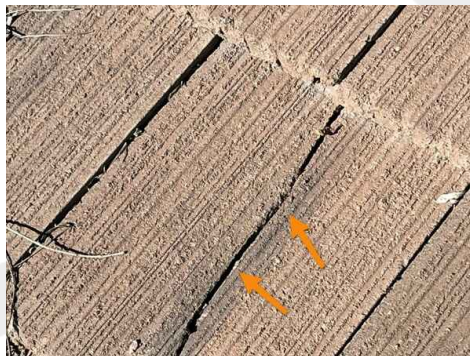
#### TILES CRACKED/BROKEN

ROOF

Roof had cracked/broken tiles. Recommend a qualified roof contractor repair or replace to prevent moisture intrusion and/or mold.

Contact a qualified roofing professional.

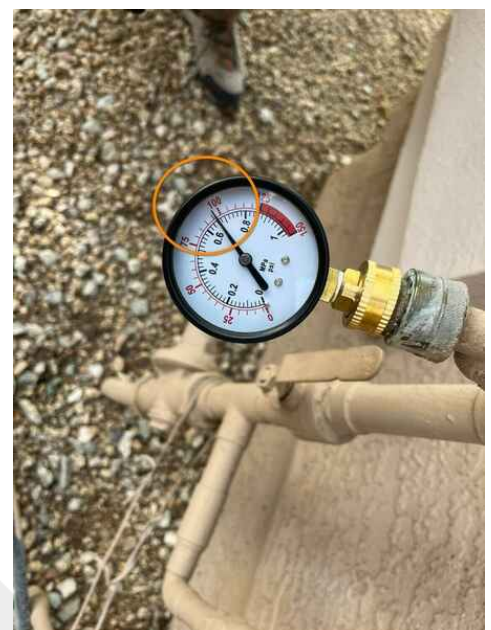
**HIGH WATER PRESSURE**

NORTHWEST

Structure plumbing water pressure was observed at beyond the high recommended limit of 80psi. High pressure may contribute to plumbing failures and damages. Recommend evaluation by professional plumber.

Contact a qualified professional.

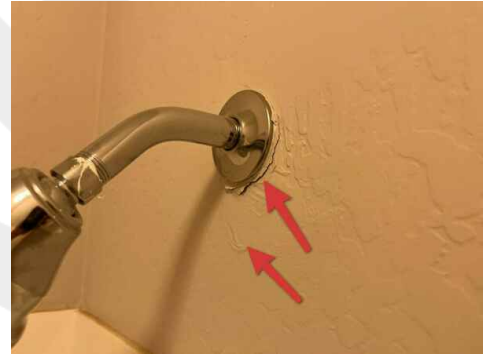
**SHOWER/BATH- SPOUT LEAK BEHIND**

BATHROOM

During testing of shower head, I observed water running out of the shower head plumbing. This is a serious water damage issue and should be repaired by a qualified plumber asap

Contact a qualified plumbing contractor.

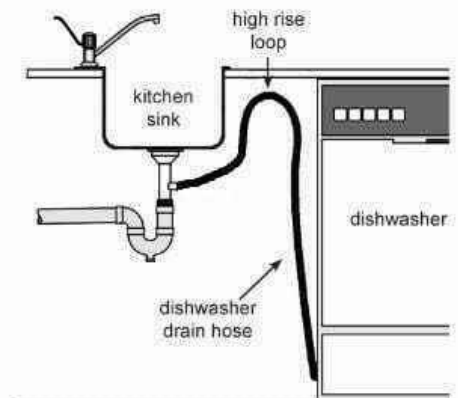
**DISH WASHER HIGH LOOP MISSING**

KITCHEN

At time of inspection the dish washer did not have appropriate high loop associated with the drain system. A missing high loop could allow contaminated water back flow into the dish washer. Recommend professional review and correction as needed

Dish Washer High Loop

Contact a qualified professional.

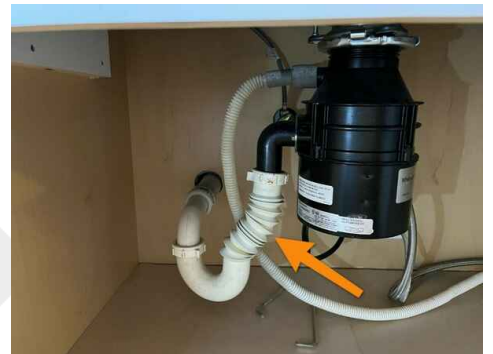
**DWV- FLEXIBLE/ CORRUGATED DRAIN PIPE**

KITCHEN

Flexible drain piping was observed in one or more locations, this can cause buildup and clogging due to pipe being corrugated. Recommend repairs and or replacement.

Contact a qualified plumbing contractor.

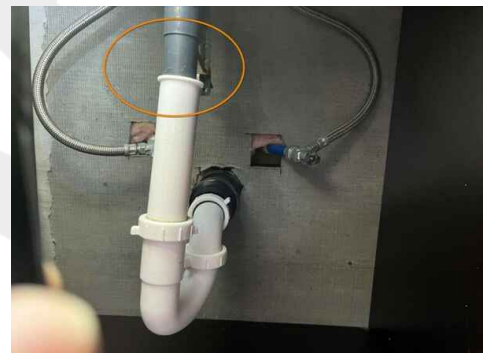
**DWV- IMPROPER CONNECTION**

BATHROOM

An improper connection was observed at a drain, waste or vent pipe. Recommend a qualified plumber evaluate and repair.

Contact a qualified plumbing contractor.

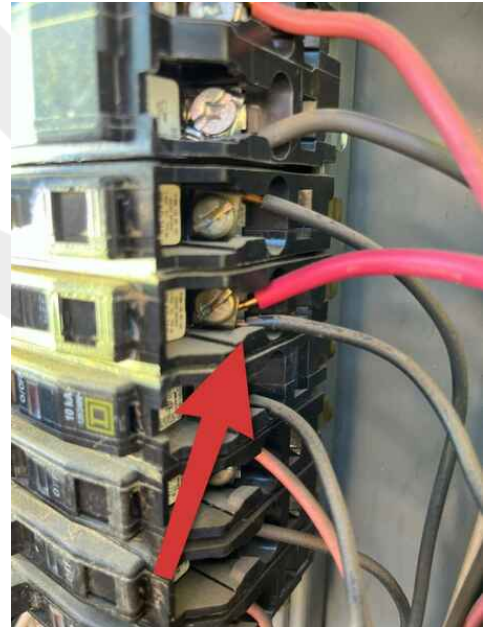
#### WIRING- DOUBLE-TAP

DISTRIBUTION PANEL

In the service panel, two wires were connected to a circuit breaker designed for only one wire. This is known as a "double-tap" and is a safety issue and this defective condition should be corrected by a qualified electrical contractor.

Contact a qualified electrical contractor.

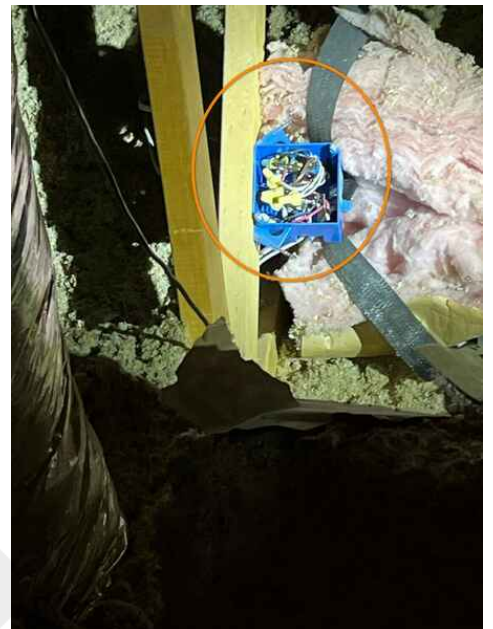
**GENERAL- J BOX COVER**

ATTIC

An open junction box was observed in one or more locations. Recommend repairs for safety.

Contact a qualified electrical contractor.

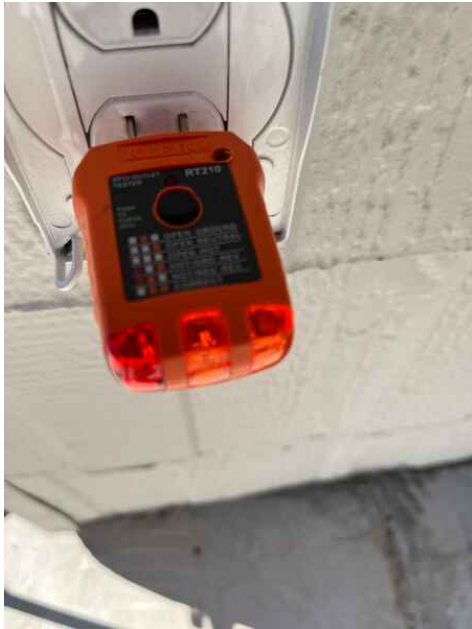
**WIRING- HOT-NEUTRAL REVERSED**

EXAMPLE: MASTER BEDROOM

Inspector observed one or more electrical receptacles with the hot and neutral wires reversed. This condition is a safety hazard and should be corrected by a qualified electrical contractor

Contact a qualified electrical contractor.

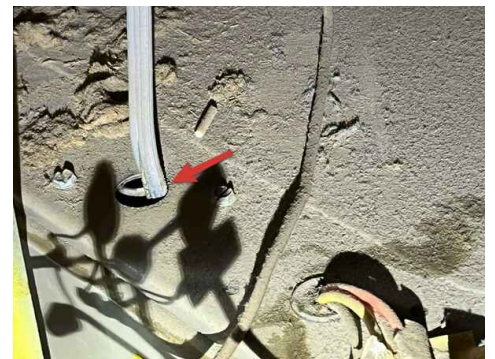
#### **EXPOSED WIRING - IMPROPER WIRING METHOD**

FURNACE

Observed electrical wiring improperly entering the furnace unit. The wiring penetration was not using the proper fitting to penetrate the enclosure. This is an electrical risk and should be reviewed and repaired by a qualified professional.

Contact a qualified electrical contractor.

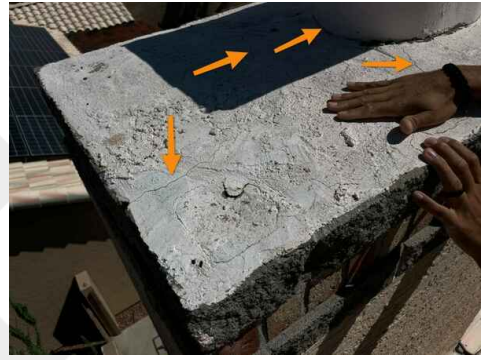
#### **CHIMNEY CAP CRACKED**

CHIMNEY

Observed cracking/gaps in the chimney cap. Cracked/damaged chimney caps can allow moisture to enter the structure and may contribute to future moisture damage. Recommend professional review/repair as needed.

Contact a qualified professional.

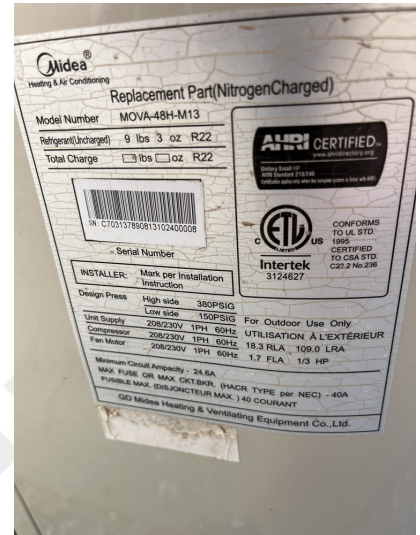
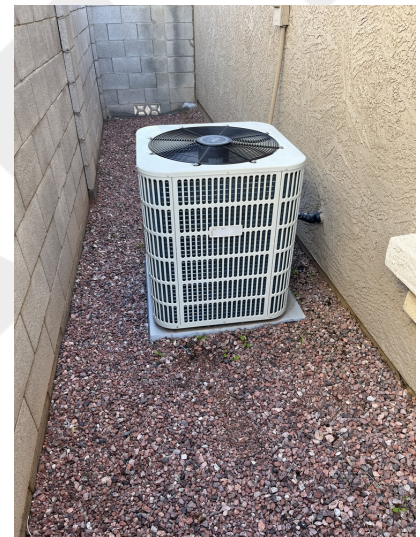
**64) Cooling Equipment : HVAC**

**64) Cooling Equipment : AC Unit Utilizing R-22**

Review of the manufacturer's data plate indicates an aging unit. The data plate also indicates the use of R-22 which is a refrigerant being phased out and currently expensive compared to new refrigerant types. Recommend consulting an HVAC professional to acquire information regarding financial impacts for potential servicing vs replacing with a more current model.

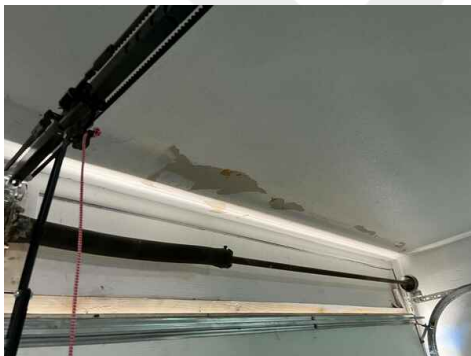
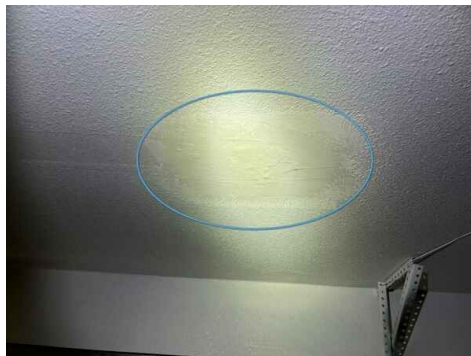
**GENERAL- PREVIOUS PATCH/REPAIR**

Previous patch or repair noted at ceiling(s). We recommend seeking further information from seller in regards to previous patch and repairs and monitoring.
